**Grant K-8 School Whole Site Modernization Project
Final MND/IS**

Slope Repair Biological Letter Report

Subject: Biological Letter Report for the Proposed Slope Repair Project at the Grant K-8 School, San Diego, California

Grant K-8 Slope Stabilization Project Site Photos

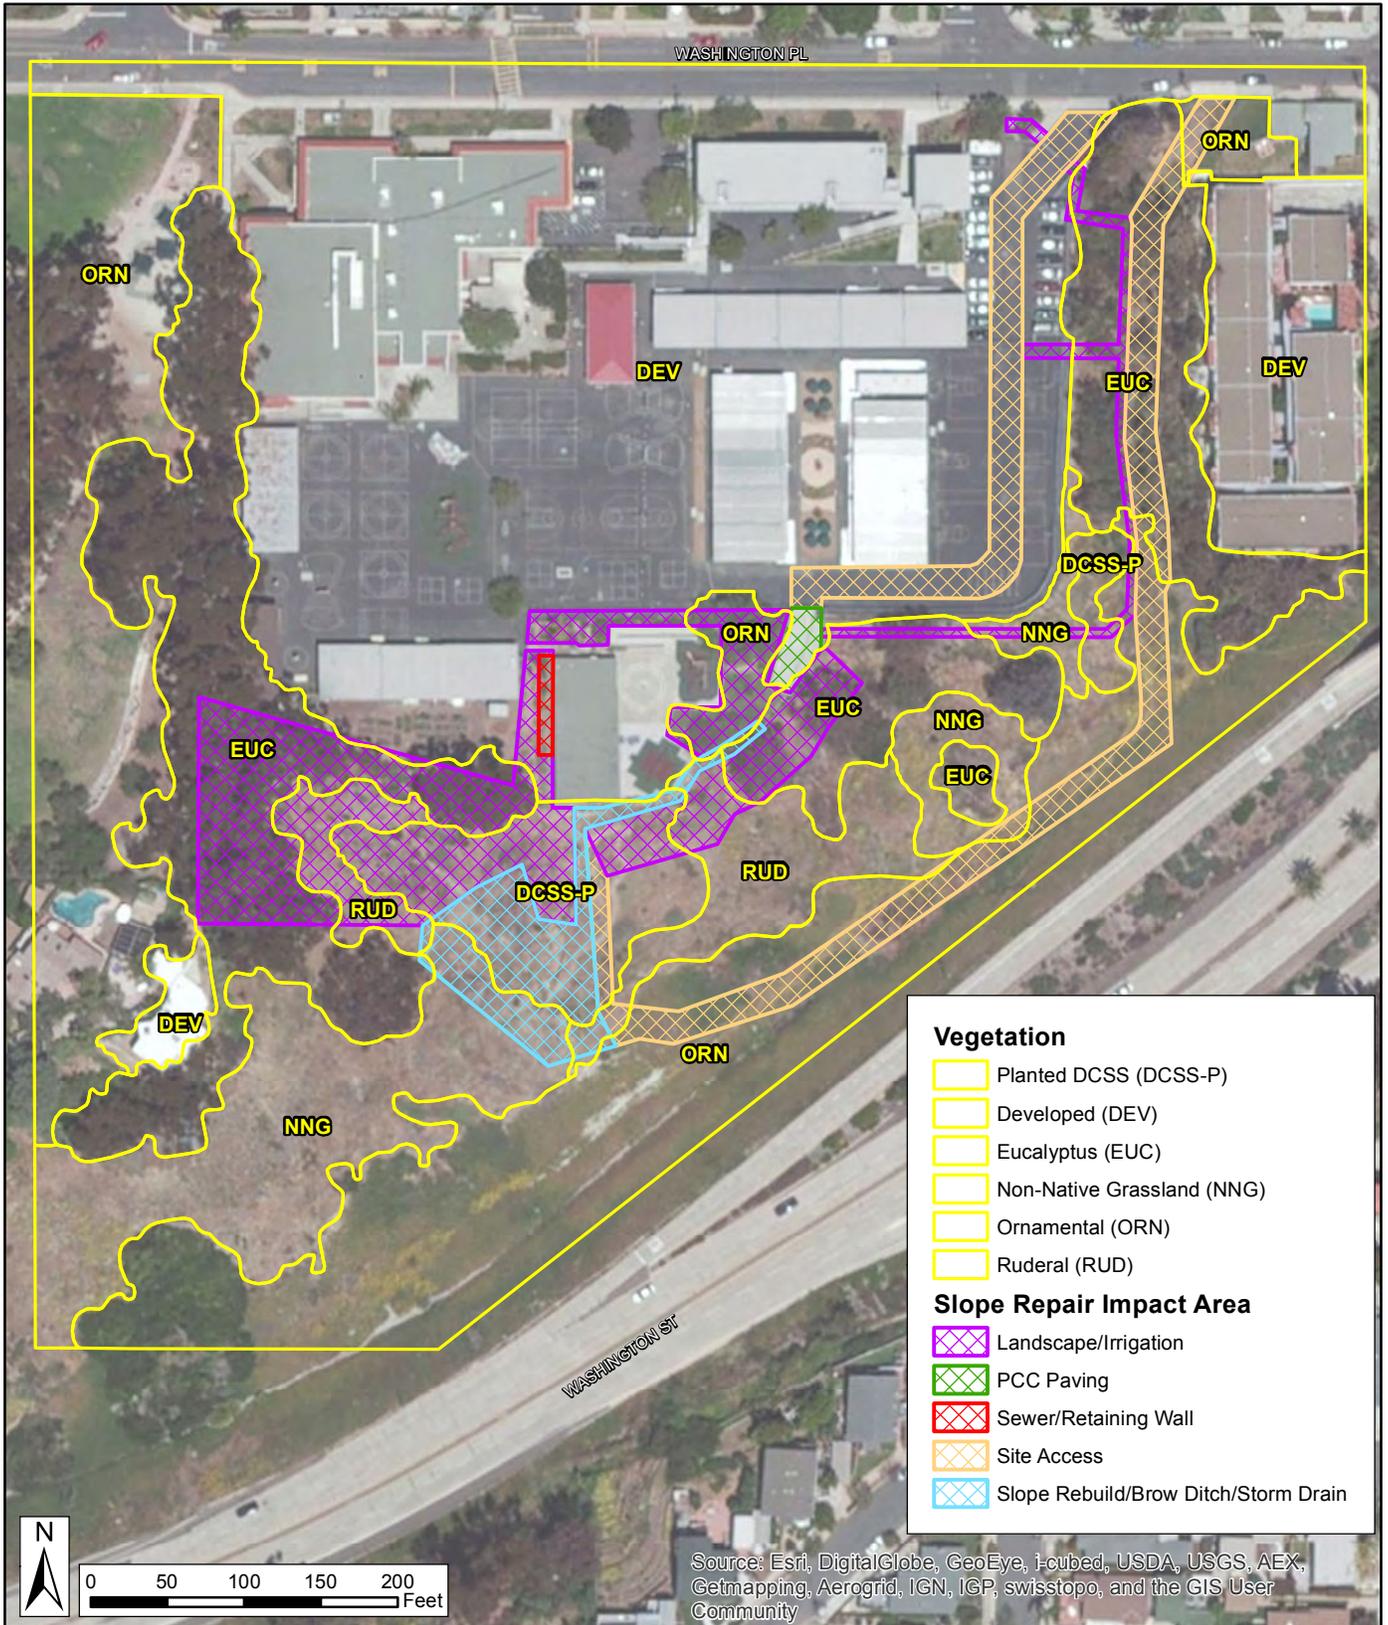
FIGURE
 2

Grant Elementary School
 Biological Resources Map
 and Project Features

Project plans were provided to Rocks Biological Consulting by BRG Consulting, Inc. (BRG) and were overlaid on the vegetation map. Project impacts were quantified by BRG using GIS software.

The proposed Project will result in impacts to 0.39 acres of Planted Diegan Coastal Sage Scrub, 0.35 acres of Developed Land, 0.6 acres of Eucalyptus Woodland, 0.09 of Non-native Grassland, 0.35 acres of Ornamental and 0.17 acres of Ruderal vegetation, collectively. Total impacts are summarized in Table 1.

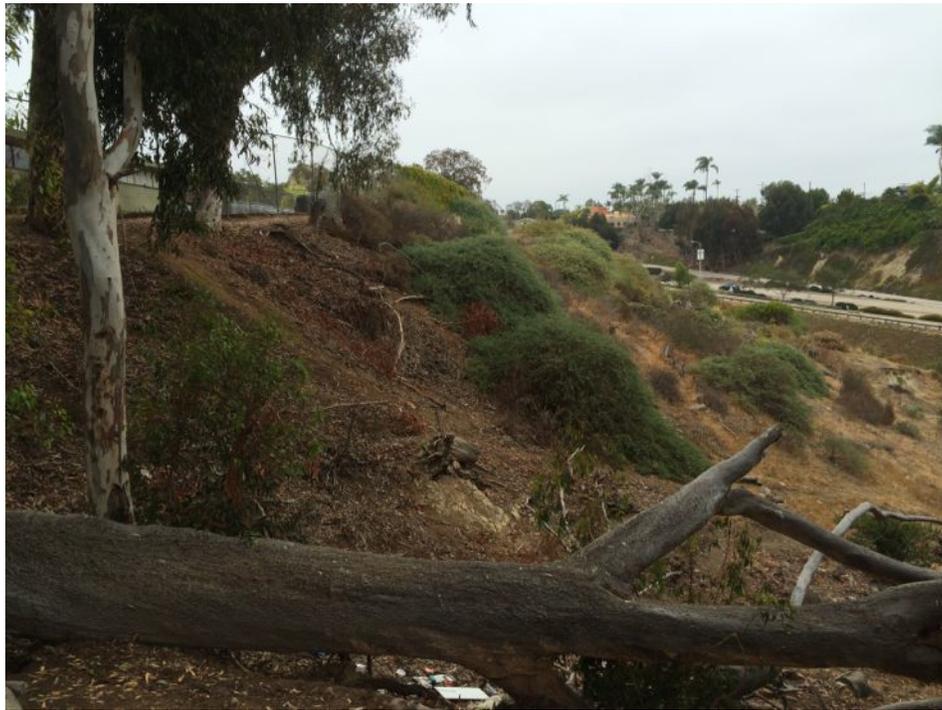
Photo 1. East-facing photo of the eroding slope with planted Diegan Coastal Sage Scrub. The chain link fence marks the existing school footprint.

The school is located on a relatively flat, developed mesa top surrounded by other development. The steep slope that needs repair is south of the school's current footprint, and slopes quickly down to West Washington Street. The slope is made of an eroding sandstone substrate. At the toe of the slope there is a concrete lined channel, which is not a blue line or ephemeral stream based on USGS mapping and does not contain hydrophytic vegetation. The concrete channel is covered in thick non-native ice plant (*Carpobrotus edulis*), and as such this area would not qualify as a wetland.

Planted Diegan Coastal Sage Scrub (DCSS-P) is typical comprised of low, soft-woody subshrubs to about 1 meter (3 feet) high, many of which are facultatively drought-deciduous. The slope was likely Diegan Coastal Sage Scrub prior to planting; however had been altered by surrounding development, non-native plantings such as Eucalyptus, and erosion. This association in its native form is typically found on dry sites, such as steep, south-facing slopes or clay-rich soils that are slow to release stored water. Due to the planted nature of this area the species observed are not typical associations of natural Diegan Coastal Sage Scrub and include some species outside of their range such as Brittlebush (*Encelia farinosa* var. *farinosa*). Species observed in the planted area include Big Saltbush (*Atriplex lentiformis*), Coast Cholla (*Cylindropuntia prolifera*) and California Sagebrush (*Artemisia californica*).

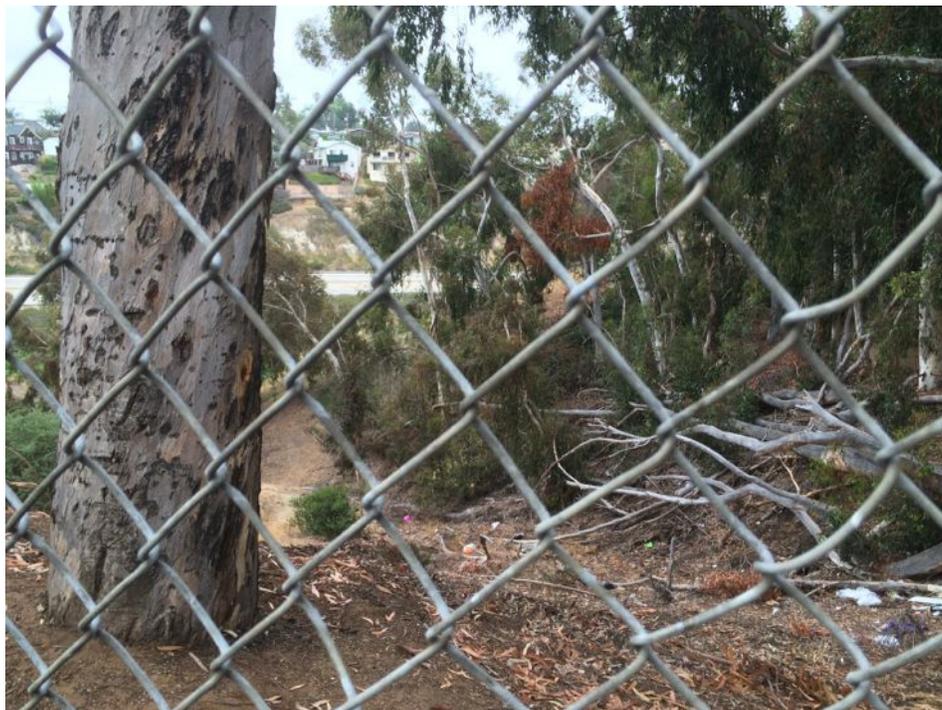
Photo 2. Facing south through the Eucalyptus area on the west side of the project adjacent to Pioneer Park. West Washington Street is visible in the background.

Eucalyptus Woodland (EUC) communities are lands dominated by Eucalyptus (*Eucalyptus* spp.) trees. Little or no understory vegetation occurs in dense Eucalyptus Woodland because of the thick accumulation of leaf litter that tends to accumulate under Eucalyptus trees. Eucalyptus trees are a non-native species that were imported from Australia and are of limited biological value except for potential raptor roosting and nesting.

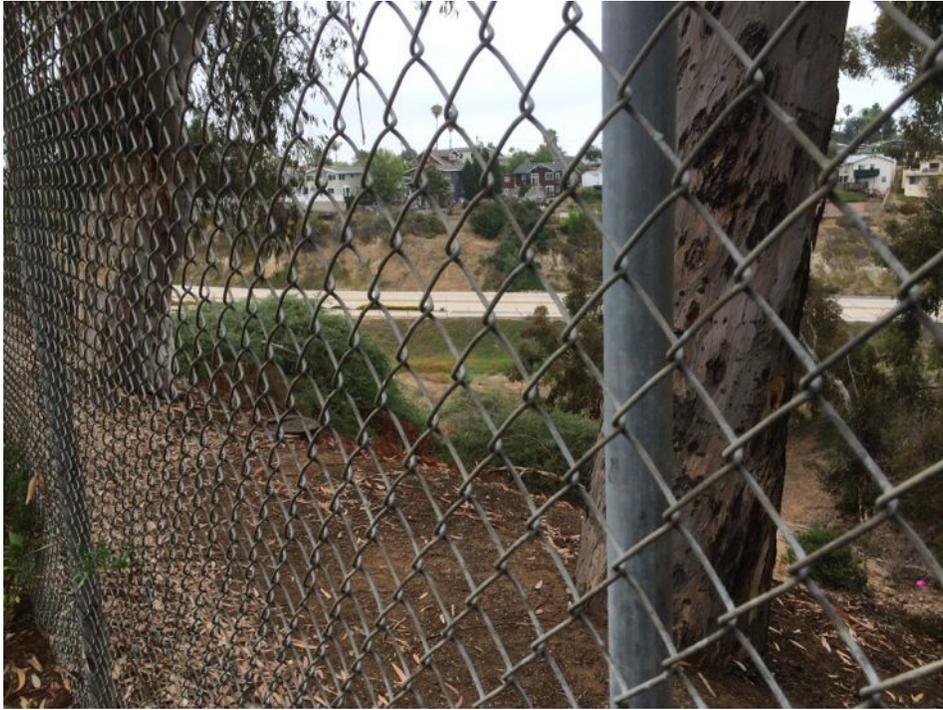
Photo 3. Facing South-east with a view of the west side of the slope that will be stabilized.
